Broom Owners Club

Perkins 6-354H and 6-354HT Engines

Survey of

spares availability

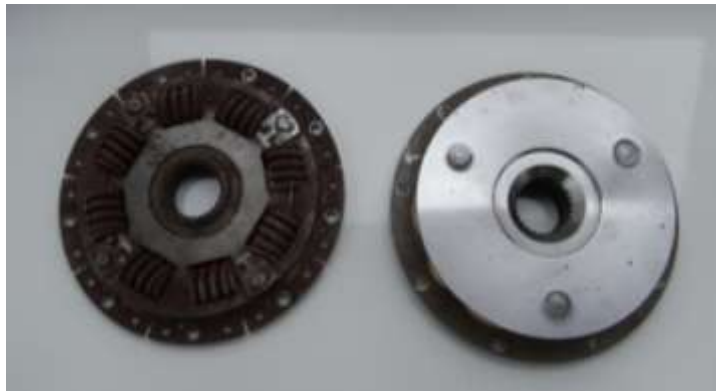
Original drive plate and modern replacement

Signs that the gearbox drive plate needs replacing due to worn splines are usually mechanical rattling noises coming from the back of the engine when on tick over. To remove the gearbox disconnect the prop shaft and push it back as far as possible (it may be necessary to remove the propeller to push the shaft past the rudder to increase clearance behind the gearbox), disconnect the change linkage, oil pressure gauge connection and water hoses to the oil cooler but it is not necessary to remove the oil cooler and oil pipes if mounted directly on top of the box. With a beam across the saloon floor bearers and rope or straps to take the weight, the gearbox can be slid backwards clear of the engine having removed the 6 retaining nuts. The drive plate, usually attached to the flywheel by 9 off ¼ “-28 UNF cap head bolts on a 6.5” PCD, can now be removed using a 3/16” across flats allen key.

Before purchasing a replacement drive plate, check the fixing dimensions as it has been stated that various flywheels were fitted during the production life of the engines and may vary from the above. If the drive plate is original, the cap head bolts were probably wire locked in position but for ease of reassembly it is more straightforward to degrease the bolts and reassemble with “locktite”.

Replacement is the reverse process but be prepared for a bit of fiddling to get the gearbox male spline to line up and slide into the drive plate female spline.

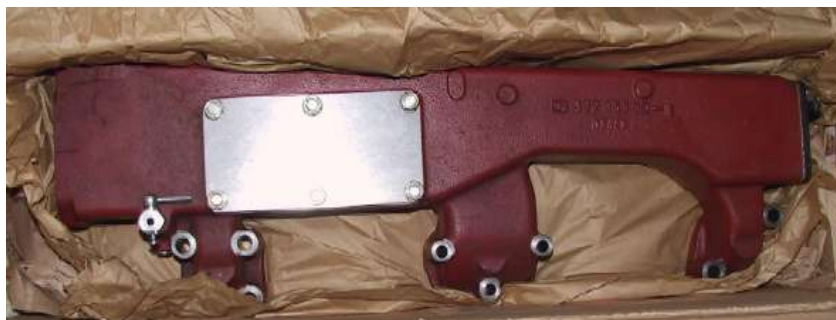
Exhaust manifold (water cooled)

The cast iron exhaust manifold has a tendency to suffer from corrosion as it is raw water cooled and has no sacrificial anode protection. Replacement manifolds are however readily available from a number of sources, both in the UK and abroad. Prices in the States appear cheaper (www.powerlinecomponents.com were quoting \$750, i.e. approx £500 as of Dec '09) but transport costs and import duty should be considered when deciding where to purchase. (Picture from Italian web site www.motoridiesel.it who were also offering manifolds)

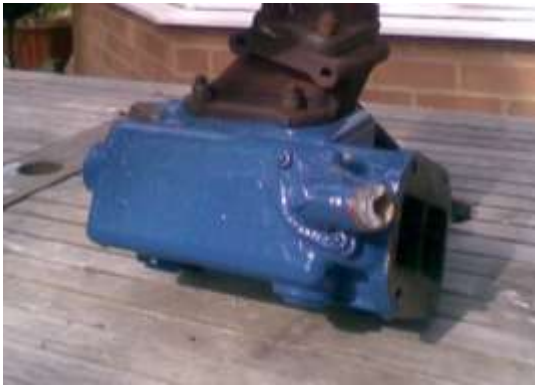
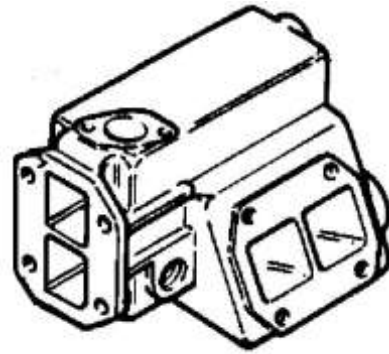
Cast aluminium exhaust manifold extension (blue) with turbo mounting.

The cast aluminium exhaust extension specific to the HT engine is liable to corrode as it tends to act as a sacrificial anode, there being no disposable anodes fitted to the engine. Perkins no longer supply the part so new components were until recently like “hens teeth”. When leaks occur due to corrosion it is sometimes possible to have the casting welded which will prolong its life but the good news is that a set of original casting patterns has been located and the owners are being encouraged to produce a batch but at the time of writing other priorities were the limiting factor. Whilst researching this component it also came to light that Finning UK Ltd, the Perkins main agent, has recently developed an alternative source for the casting which is now available ex stock. Hopefully two potential sources of supply will bring the cost down.

In the meantime fabricated parts appear to offer an alternative and lower cost solution. In France, a Broom owner is attempting to fabricate mild steel replica fittings including water cooling jackets on the basis that the material is easy and relatively cheap to work and can be protected with sacrificial anodes. He has agreed to keep me informed of progress.

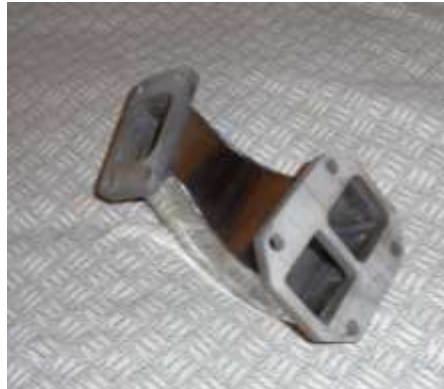
Fabricated stainless replacement

Alternatively, Lancing Marine produce a stainless fabrication (as above) which whilst it looks quite different, replicates the exhaust duct but without the water cooling jacket so will require lagging with fibreglass tape and a minor modification to the raw water cooling system, i.e., connecting the exhaust manifold water outlet directly to the exhaust pipe water injector.

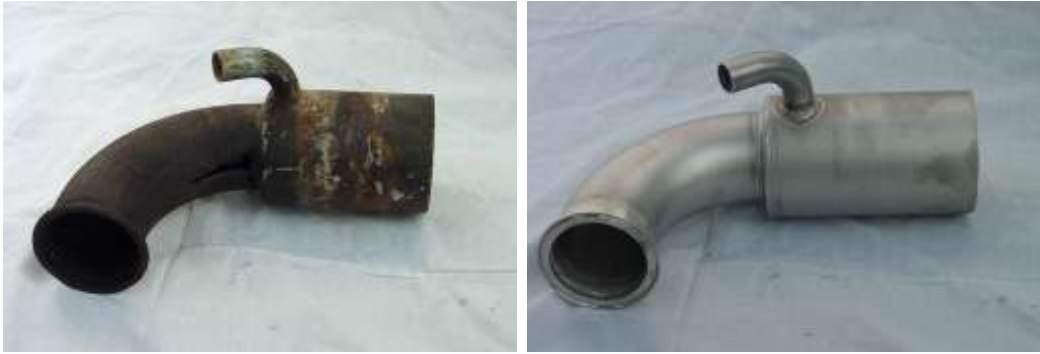
Original Perkins exhaust outlet showing heavy corrosion and a replacement exhaust manufactured from 316 stainless

Lancing Marine offer a fabricated stainless steel replacement but an alternative route may be through a local stainless steel fabricator and the use of hygienic fittings as used in the food and beverage process industries. Both the 3" dia bend, the 1" dia bend for the water injector and the 4" dia outer tube are all industry standard components available in S316 16 swg marine grade material. In the example shown above the connecting flange was machined to the same sizes as the original (see appendix 111) but standard "tri-clamp" fittings are very similar. Reducers from 4" dia to 3" dia can also be obtained as standard components but the short length of 4" dia outer tube may need to be fabricated if an off cut is not available as most stockists will only supply in 6m (20ft) lengths.

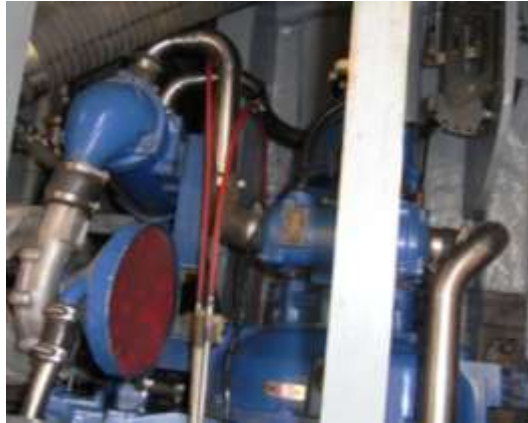
Raw water system fabricated from 1½” stainless tubing.

Design of the raw water cooling system with the pump in the middle imposes negative pressure on all hose connections and fittings between the inlet sea cock and pump. As a result when moulded rubber elbows age and loose stiffness, there is a tendency for the elbows to collapse when running at higher engine speeds, restricting raw water flow and causing overheating. This can be overcome by inserting tubular metal segments into the elbows to stop collapsing or replacing them with suitably sized (28mm or 35 mm copper or 1.5” dia stainless) formed metal bends connected into the system with short lengths of rubber hose and jubilee clips.

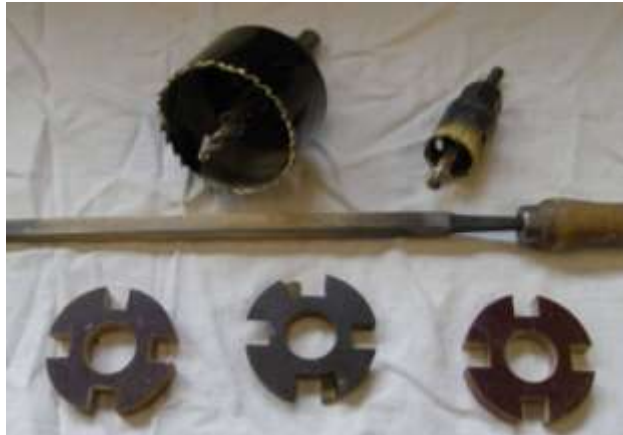
Drive disc in the centre clearly showing wear due to age and vibration

Connection between the engine and pump drive shafts is a disc of hard plastic, 3/8" thick with 4 square slots which engage on two protrusions on flanges fitted to each shaft and over time the slots can elongate due to vibration. No spares source for connectors has been located but satisfactory replacements can be made from 3/8" thick "paxalin" or "tufnol", materials which appear similar in appearance and characteristics to the original but any similar material or hard plastic would suffice and thickness is not too critical as the pump assembly can be slid longitudinally in its circular clamp.

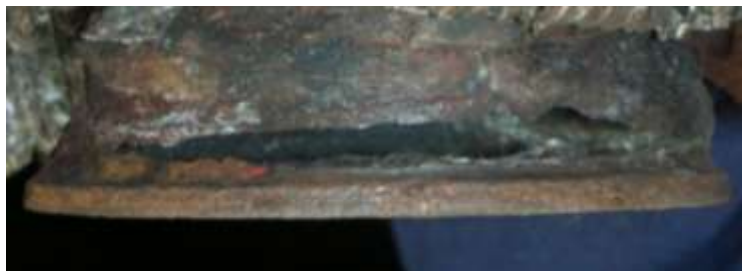
Corroded flange with large hole

The turbocharger outlet which directs the exhaust through 90°, swivels on circular flanges in order to line up with the exhaust pipe. The body is made of stainless steel whilst the flanges are carbon steel and therefore prone to corrosion over time, the indication of pending failure being leakage of exhaust fumes into the engine area. The unit can however be salvaged by carefully cutting off the corroded flange(s) leaving as much of the original formed upstand as possible and welding on new flanges machined from stainless steel. In the L.H. illustration one flange was an internal press fit before welding and the other an external press fit. The outlet was cleaned up for the photo but after 2 years use shows no signs of deterioration.

New outlets are available from Trans Atlantic Diesel Inc (see www.tadiesels.com) but a quick "get you home" flanged elbow can be constructed from standard hygeinic 3" dia bends and "tri-clamp" flanges obtained from a stainless steel component distributor although in the illustration the flanges were machined as shown in appendix III.

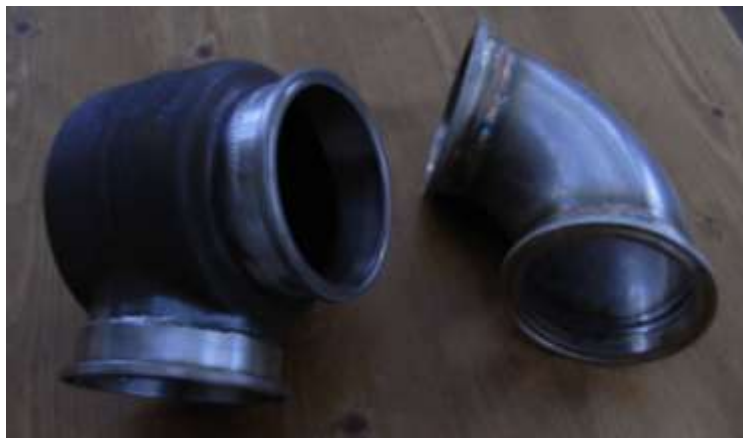
Outlet after fitting replacement flanges and an alternative solution using a 90° stainless bend

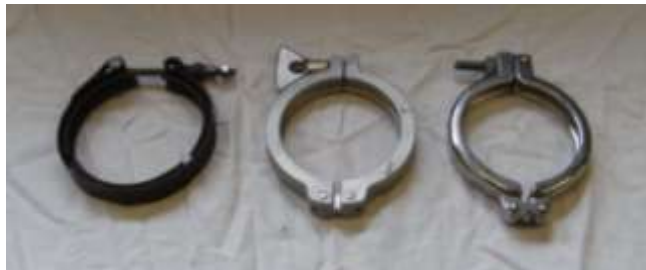
Banjo clamp (left hand) which has had the threaded swivel bolt replaced and 2 versions of the 3” tri-clamp.

The two banjo clamps which hold the exhaust system together suffer deterioration due to heat with the nut often seizing on the threaded swivel bolt to such an extent that the bolt shears when attempting to undo the nut. If suitable facilities are available the clamp can be salvaged by replacing the bolt and if so, try to obtain bronze nuts (try your local replacement car exhaust outlet and ask for a suitable manifold nut) to avoid seizure in the future. If the clamp cannot be repaired standard stainless 3” “tri-clamp” hygienic fitting clamps work equally well.
